I-30/I-40 SAFETY EXISTING CONDITIONS

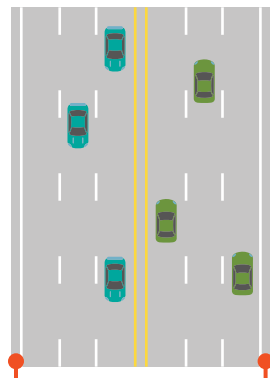
SHOULDERS

9 Deficient Locations
Inadequate shoulder widths

Existing shoulders range from 1-6 ft wide and proposed widths are 10 ft or greater

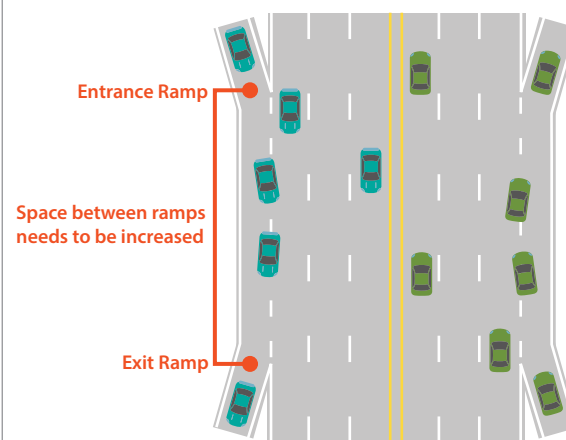
RAMP SPACING

11 Deficient Locations
Lack of required spacing to safely allow weaving between entrance/exit ramps

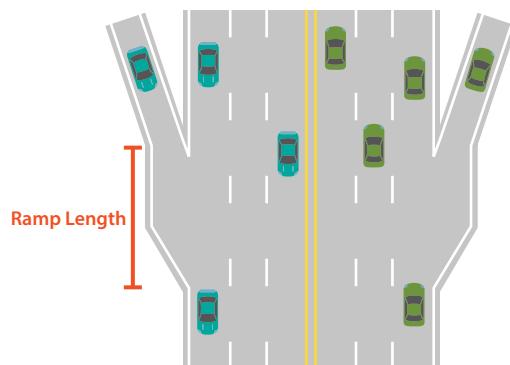
RAMP LENGTH

15 Deficient Locations
Ramps lack recommended lengths

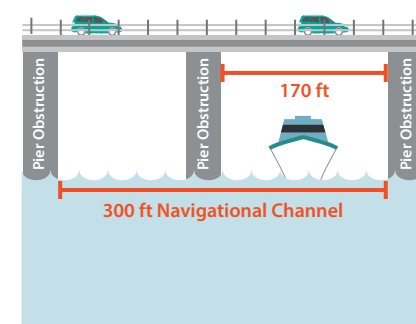
RIVER NAVIGATION

1 Deficient Location
Pier obstructions in navigational channel under I-30
